EAST HAVEN, CONNECTICUT

GARNISS POND DAM
CT-00114

NATIONAL DAM INSPECTION PROGRAM
CORPS OF ENGINEERS

Graniss Pond Dam
TR - Farm River
East Haven, Connecticut
CE# 27 660 KD
DATE 9/18/79 PAGE C-1

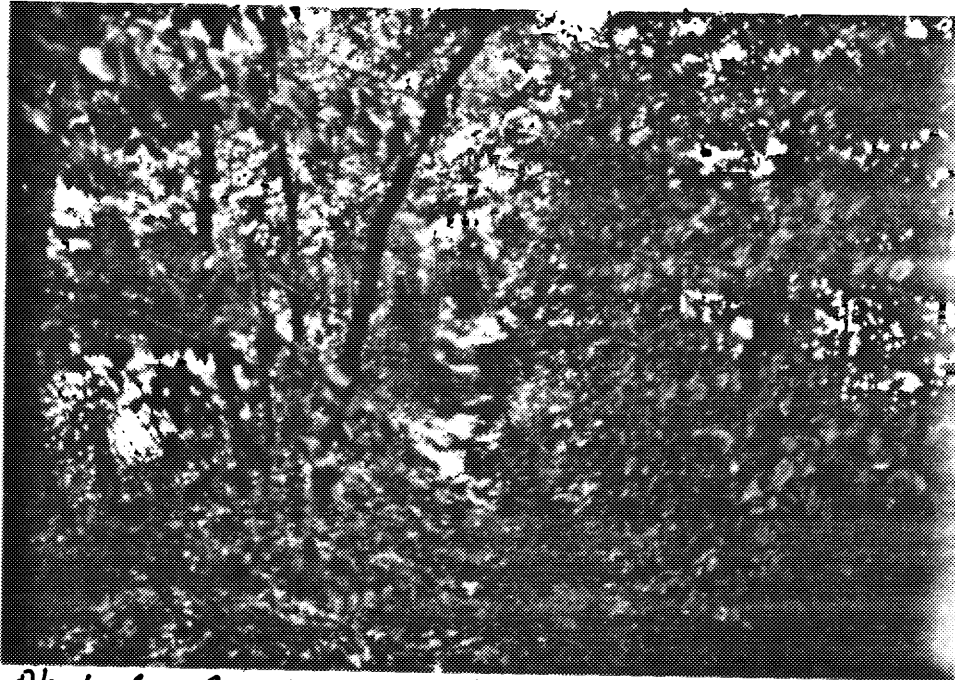
The findings of our visual inspection revealed that the condition of the dam is poor. The upstream weir is deteriorated and has fallen to a state of disrepair (Photo Page 3). The downstream weir has several areas of seepage at the downstream side (photo 5 and 6). The crest and slopes are overgrown with trees and brush (photos 1 and 2).

Photo 1 - Crest of dam. Runoff pipe over crest in background.

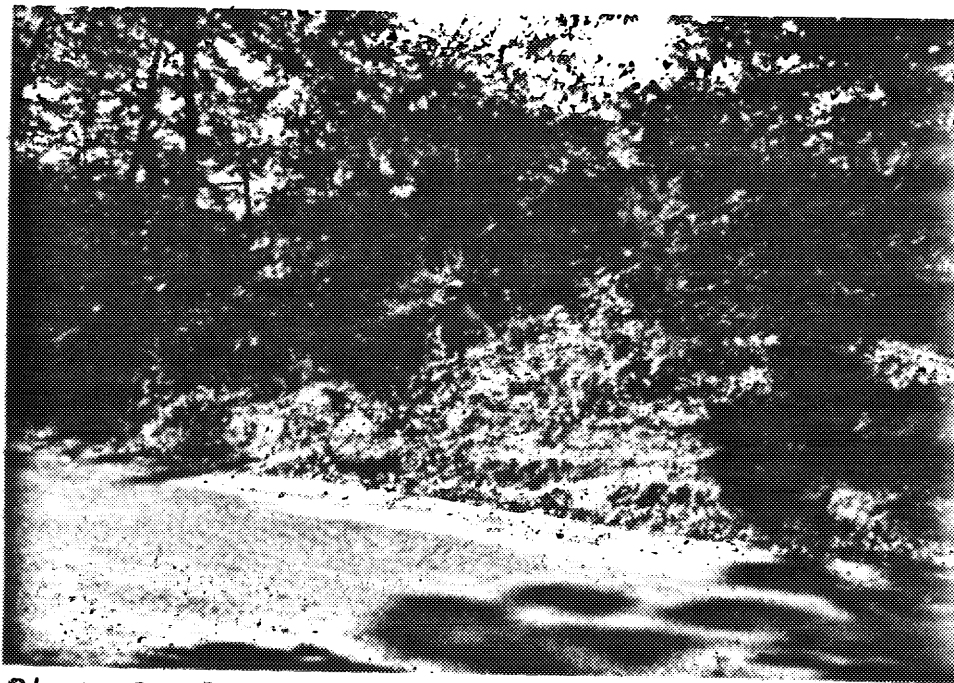
Photo 2 - Downstream Slope of dam. Runoff (6") in center and Graniss Street in foreground.

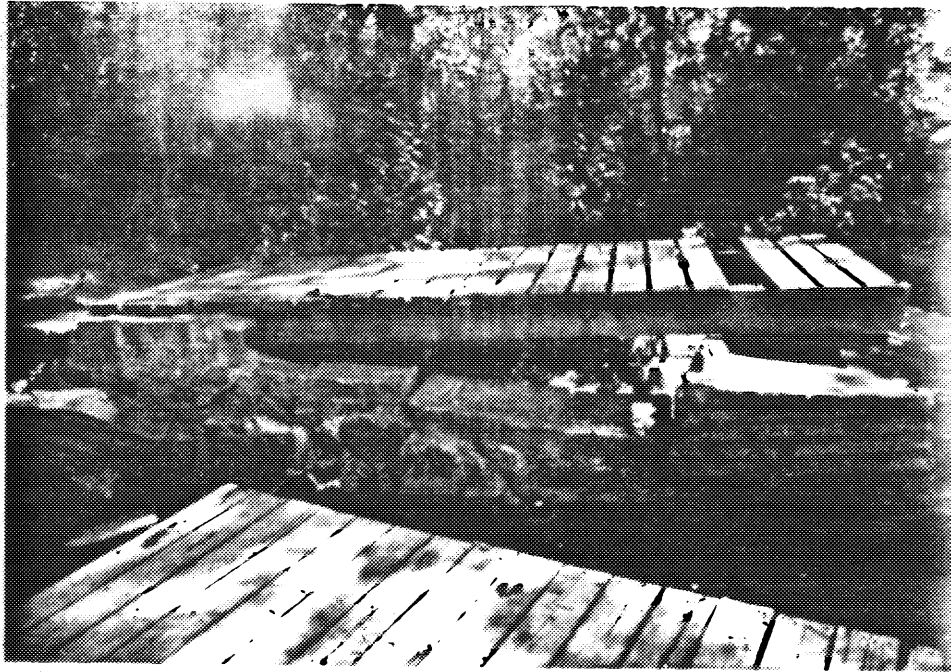
Photo 3 - Upstream weir and spillway channel. Downstream weir in background.

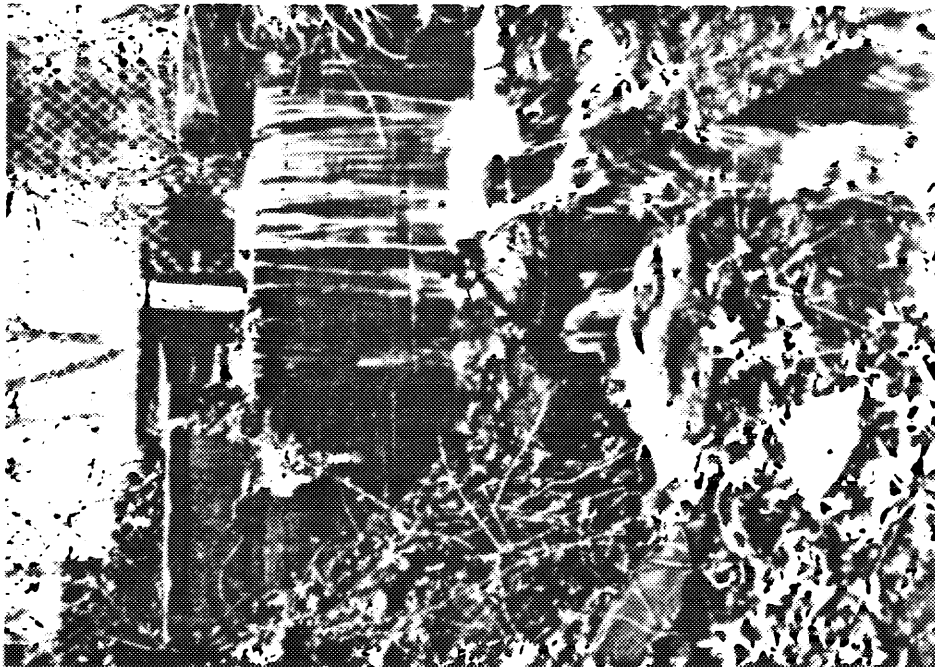
Photo 4 - Downstream weir, outlet valve and channel to 15" R.C.P. from downstream.

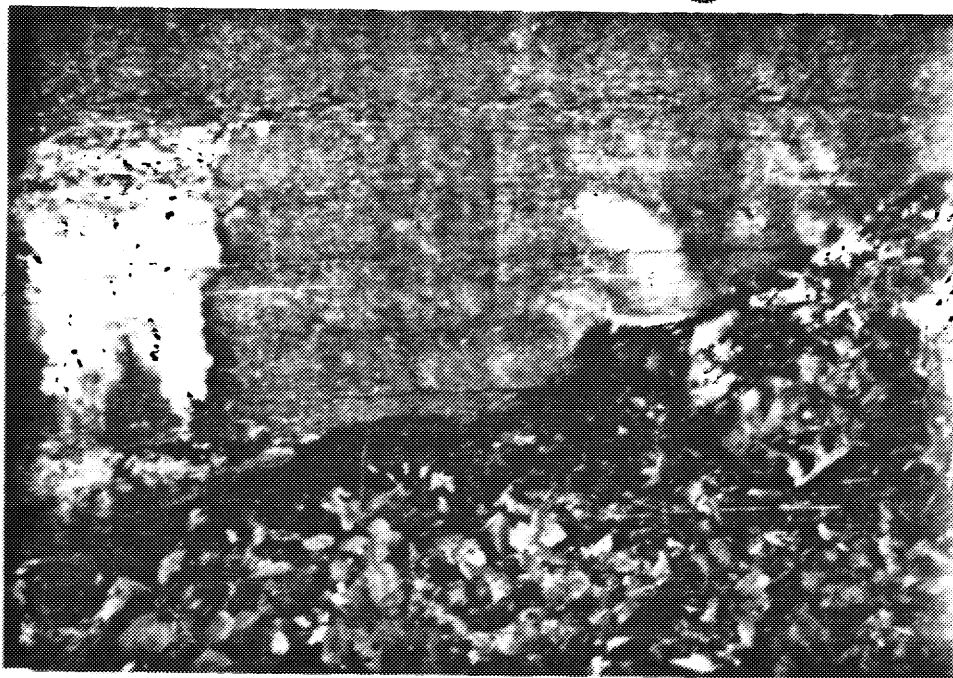
Photo 5- Seepage, efflorescence and cracking at downstream weir.

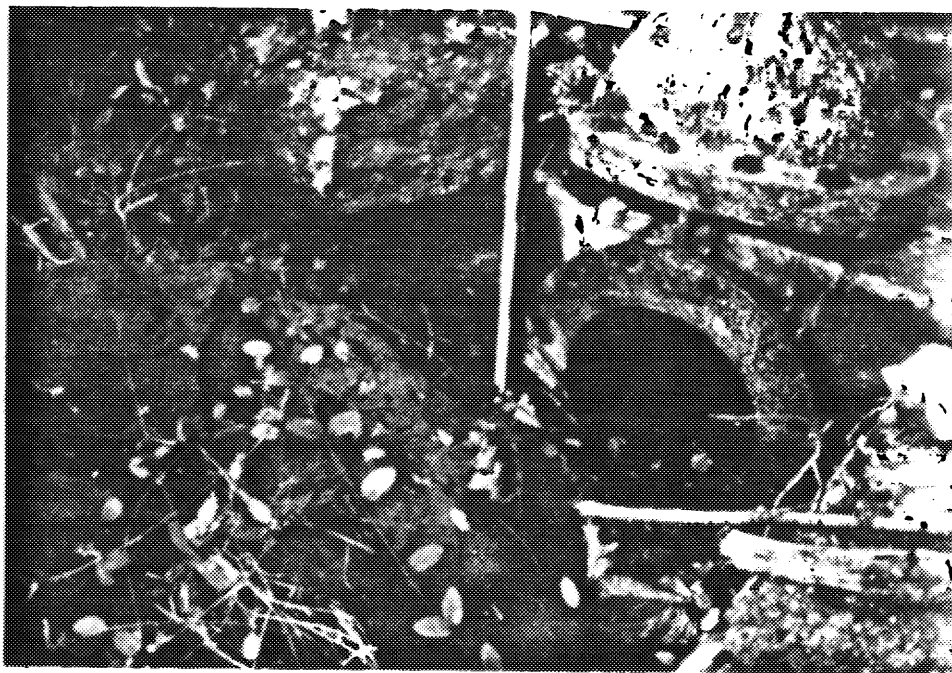
Photo 6 - 12" outlet valve below downstream weir. Note seepage to left of valve opening.

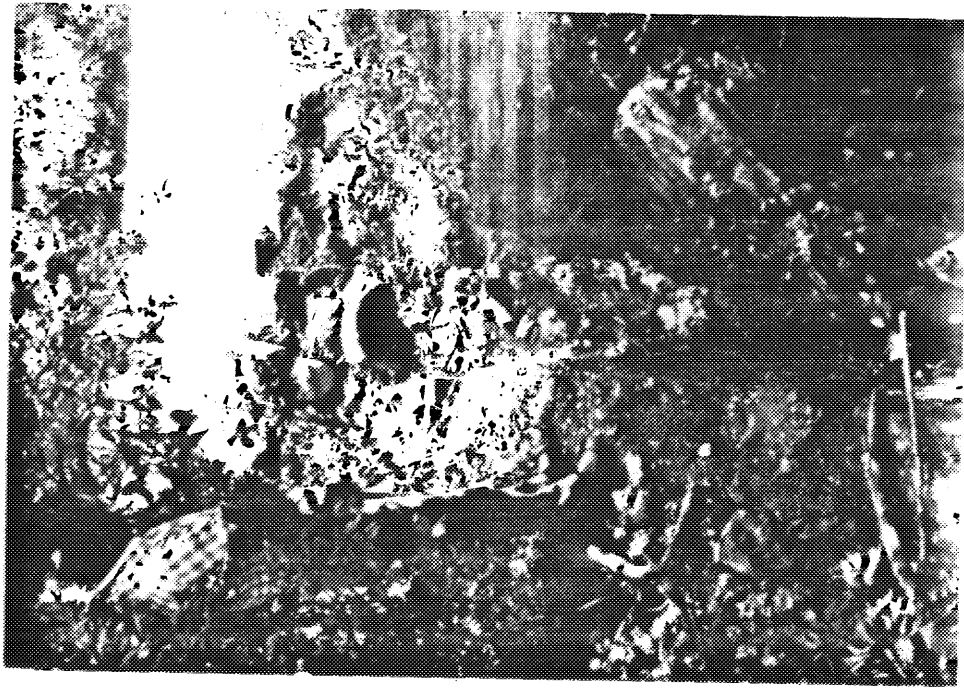
Photo 7 - Channel to 15" R.C.P. under Graniss Street. Valve stem in foreground.

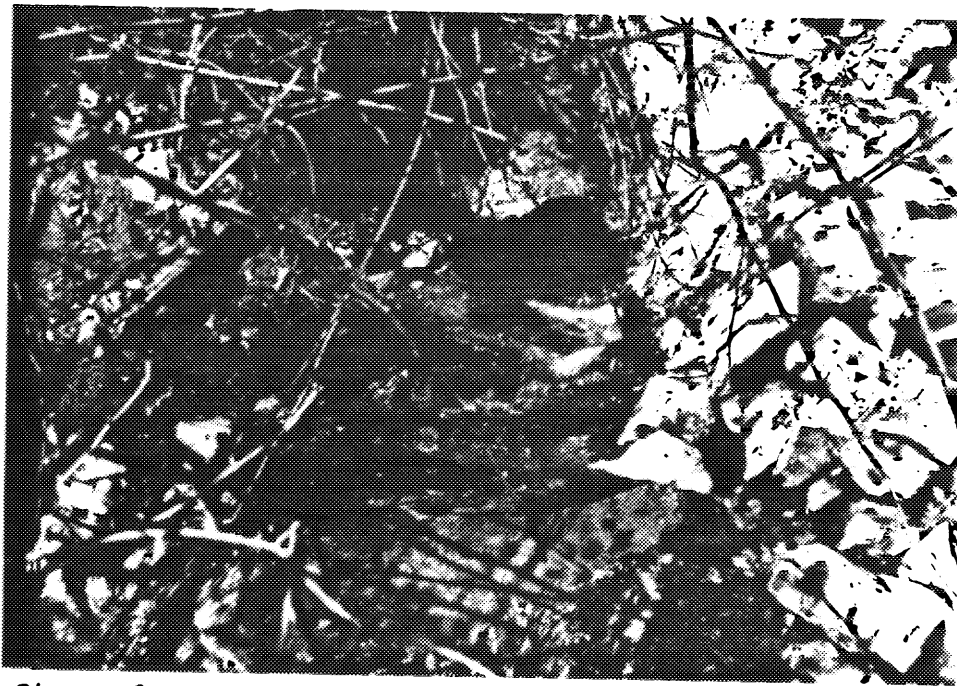
Photo 8 - 15" R.C.P. outlet and riprap at downstream side of Graniss Street.

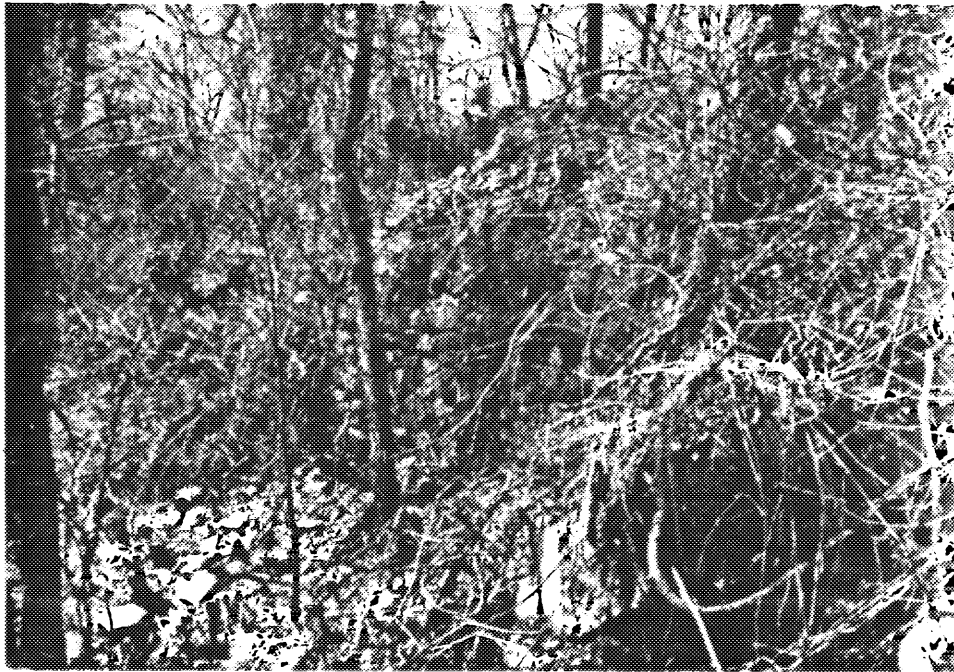
Photo 9 - Stone wall at downstream side of Graniss Street.

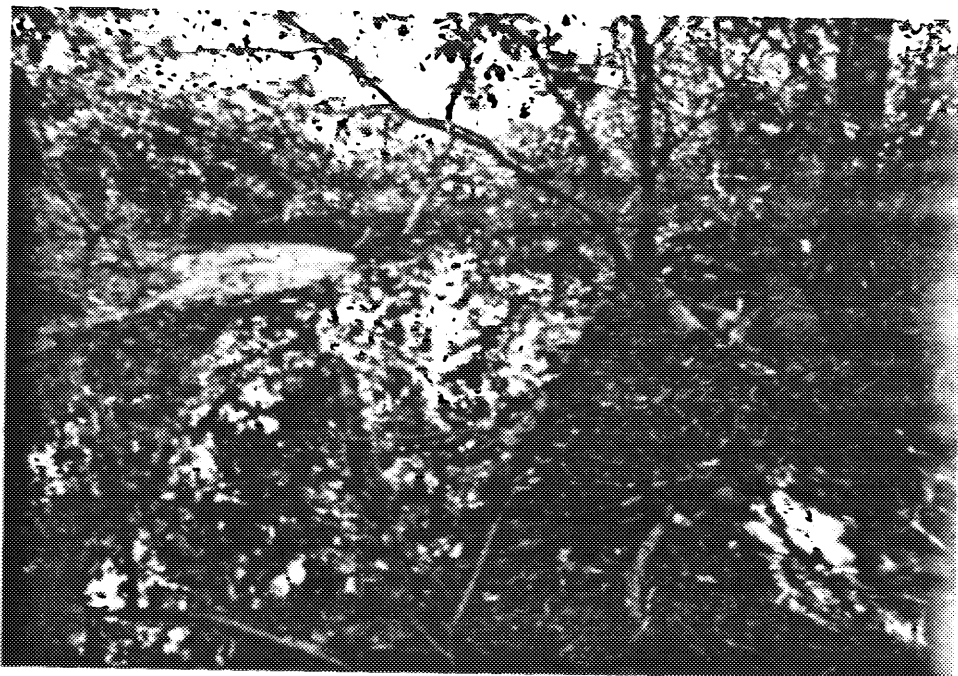
Photo 10 - Ponded water and concrete retaining wall at downstream side of Graniss Street.
